**CONCORRÊNCIA INTERNACIONAL Nº 1/2025**

**International Competition for the ADMINISTRATIVE CONCESSION FOR  
THE CONSTRUCTION, EQUIPPING, OPERATION, MAINTENANCE AND  
PROVISION OF SERVICES OF THE HOPE HEALTH COMPLEX**

**APPENDIX 4.2**

**ENVIRONMENTAL LIABILITY REGISTRATION FORM**

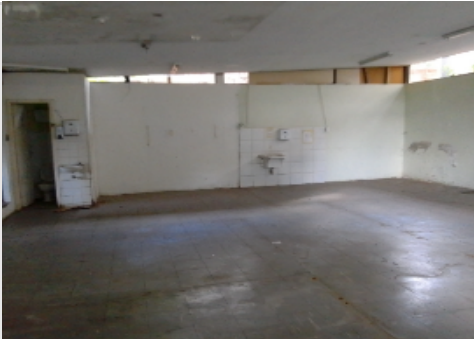
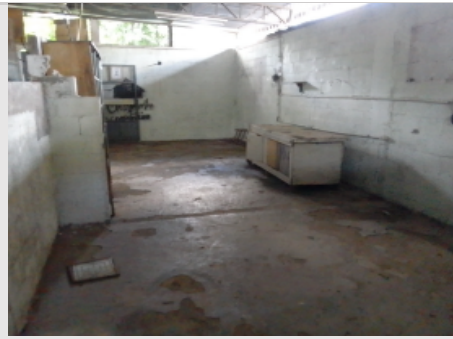
<b>Asset</b>	HGV		<b>Area: Maintenance/Carpentry</b>		
<b>Liability Code</b>	3_AC_Interno		X	Within the asset/Right-of-Way	
				Outside the asset/Right-of-Way	
<b>Municipality</b>	Belo Horizonte		<b>State</b>	MG	
			<b>Date</b>	02/06/2024	
<b>Coordinates</b>		<b>Generator</b>		<b>Responsibility</b>	
Latitude	Longitude	X	Client	Current Management	
-199.278	-439.852		Others: _____	X	Future Concession
<b>Evidence</b>	X	Visual	<b>Type of liability</b>		
		Irregular discharge of effluent			
		Odor			
	X	Area history			
		Others: _____			
<b>Potential generating factor</b>	Substance leakage		Contamination Potential (AP)		
<b>Dimension</b>			Siltling of Watercourse (SW)		
Área (m <sup>2</sup> )	340		Exposed Soil (ES)		
Depth (m)			Waste Deposition (WD)		
Volume (m <sup>3</sup> )			Erosive Process (EP)		
Others			Impermeabilized Area (IA)		
<b>Observations</b>			<b>Risk</b>		
			X	Does not pose apparent risks	
				Risk to human health

Structural risk	
			Risk of liability progression

The future concessionaire must submit the Contaminated Area Management Program, identifying contaminated areas and potentially polluting areas that will be intercepted by the enterprise, in accordance with the procedures for Contaminated Area Management approved by COPAM/CERH Joint Normative Resolution No. 02/2010, dated September 8, 2010, which must include:

Contaminated Area Identification Process:

- Preliminary Assessment;
- Confirmatory Investigation, in applicable cases;
- Detailed Investigation, where applicable;
- Risk Assessment.

Contaminated Area Rehabilitation Process (PRAC):

Development and implementation of an Intervention Plan.

Environmental monitoring of contaminated area management until the issuance of the rehabilitation certificate for Declared Use.

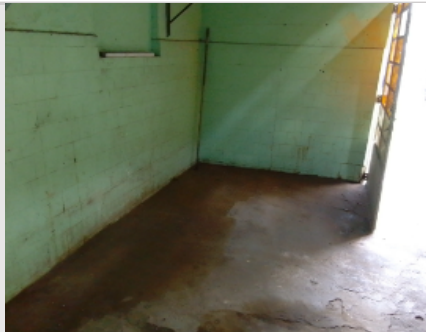
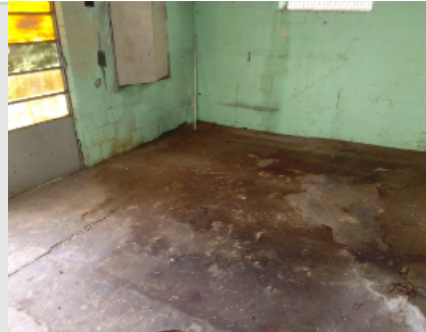
<b>Asset</b>	HGV		<b>Area: Maintenance/Carpentry</b>		
<b>Liability Code</b>	2_AC_Interno		X	Within the asset/Right-of-Way	
				Outside the asset/Right-of-Way	
<b>Municipality</b>	Belo Horizonte		<b>State</b>	MG	
			<b>Date</b>	02/05/2024	
<b>Coordinates</b>		<b>Generator</b>		<b>Responsibility</b>	
Latitude	Longitude	X	Client	Current Management	
-199.278	-439.858		Others: _____	X	Future Concession
<b>Evidence</b>	X	Visual	<b>Type of liability</b>		
		Irregular discharge of effluent			
	X	Odor	X	Contamination Potential (AP)	
	X	Area history		Silting of Watercourse (SW)	
			Exposed Soil (ES)		
			Waste Deposition (WD)		
<b>Potential generating factor</b>	Oil Spill			Erosive Process (EP)	
				Impermeabilized Area (IA)	
<b>Dimension</b>				Others: _____	
Área (m <sup>2</sup> )	56		<b>Risk</b>		
Depth (m)				Does not pose apparent risks	
Volume (m <sup>3</sup> )				Risk to human health	
Others				Structural risk

<b>Observations</b>			X	Risk of liability progression

The future concessionaire must submit the Contaminated Area Management Program, which includes the identification of contaminated areas and potentially polluting areas that will be intercepted by the project, in accordance with the procedures for Contaminated Area Management approved by COPAM/CERH Joint Normative Resolution No. 02/2010, dated September 8, 2010, which must include:

Contaminated Area Identification Process:

- Preliminary Assessment;
- Confirmatory Investigation, in applicable cases;
- Detailed Investigation, where applicable;
- Risk Assessment.

Contaminated Area Rehabilitation Process (PRAC):

Development and implementation of an Intervention Plan.

Environmental monitoring of contaminated area management until the issuance of the rehabilitation certificate for Declared Use.

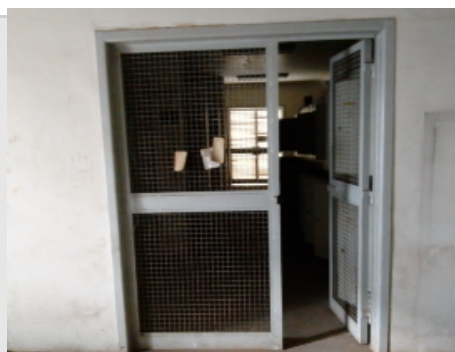
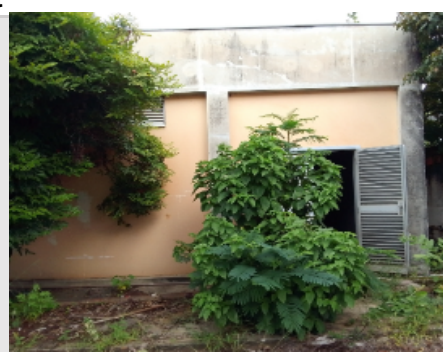
<b>Asset</b>	HGV		<b>Area: Maintenance/Carpentry</b>			
<b>Liability Code</b>	1_AC_Interno		X	Within the asset/Right-of-Way		
				Outside the asset/Right-of-Way		
<b>Municipality</b>	Belo Horizonte		<b>State</b>	MG		
			<b>Date</b>	02/05/2024		
<b>Coordinates</b>		<b>Generator</b>		<b>Responsibility</b>		
Latitude	Longitude	X	Client	Current Management		
-199.278	-439.853		Others: _____	X		
<b>Evidence</b>			Visual	<b>Type of liability</b>		
			Irregular discharge of effluent			
		X	Odor			
		X	Area history			
<b>Potential generating factor</b>		Power Transformers		Exposed Soil (ES)		
				Waste Deposition (WD)		
<b>Dimension</b>		72		Erosive Process (EP)		
				Área (m²)		Impermeabilized Area (IA)
				Depth (m)		Others: _____
				Volume (m³)		
Others				<b>Risk</b>		
<b>Observations</b>				Does not pose apparent risks		
				X	Risk to human health	
					Structural risk	
				Risk of liability progression

Polychlorinated Biphenyls (PCBs) are synthetic chemical compounds that have harmful effects on human health and the environment.

For the demolition phase of the former Galba Velloso Hospital, Federal Law No. 14,250, dated November 25, 2021, addresses the controlled elimination of materials, fluids, transformers, capacitors, and other electrical equipment contaminated by polychlorinated biphenyls (PCBs) and their residues, recommending:

- a) Issue a report identifying all transformers containing PCBs;
- b) Label transformers containing PCBs clearly and visibly;
- c) Remove them from the area carefully, avoiding leakage, while being properly protected with PPE;
- d) Transformers contaminated by PCBs must be disposed of in an environmentally appropriate manner; otherwise, they may be classified as non-contaminated by PCBs.

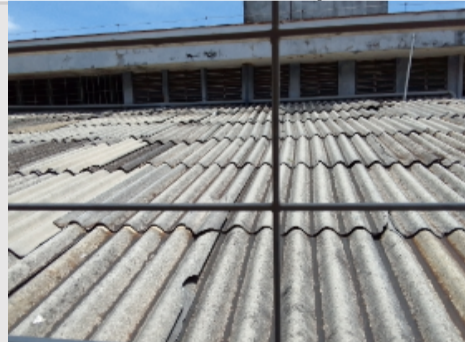
<b>Asset</b>	HGV		<b>Area: Maintenance/Carpentry</b>		
<b>Liability Code</b>	4_AC_Interno		X	Within the asset/Right-of-Way	
				Outside the asset/Right-of-Way	
<b>Municipality</b>	Belo Horizonte		<b>State</b>	MG	<b>Date</b> 02/06/2024
<b>Coordinates</b>		<b>Generator</b>		<b>Responsibility</b>	
Latitude	Longitude	X	Client		
-199.279	-439.860		Others:		
<b>Evidence</b>	X	Visual			<b>Type of liability</b>
		Irregular discharge of effluent			
		Odor			
		Area history			
		Others:			
<b>Potential generating factor</b>	Asbestos Roof Sheets		X	Contamination Potential (AP)	
				Siltation of Watercourse (SW)	
				Exposed Soil (ES)	
				Waste Deposition (WD)	
				Erosive Process (EP)	
				Impermeabilized Area (IA)	
				Others:	
				<b>Risk</b>	
				Does not pose apparent risks	
			X	Risk to human health	
				Structural risk	
				Risk of liability progression

Exposure to asbestos poses a range of risks to human health and the environment. To prevent exposure risks to the workers involved, as well as to the surrounding neighborhood and environment during the demolition phase, Resolution 348/04 of the National Environmental Council (Conama), N15, and State Law No. 21,114 of 12/30/2013, recommend:

- 1) The removal of asbestos roofing should be conducted by qualified professionals and companies, following NR 15 standards. The area must be isolated, and workers must use special PPE, such as Tyvek suits, masks, and filters.

- 2) The roofing sheets should be removed whole and intact. They must be wrapped in two layers of plastic, labeled, and secured with straps. The sheets can be placed on pallets or in impermeable bags, also labeled. This is done to prevent the release of fibers and to prevent accidents during removal.

- 3) Broken asbestos waste should be placed in polyethylene big bags to prevent airborne fiber exposure. The bags should be filled halfway, moistened, and the air carefully removed to avoid dust release. They must be labeled according to NR 15 and cleaned externally before being removed from the work area. After decontamination, they should be re-bagged outside the asbestos removal area.

- 4) After proper removal and storage, the roofing sheets should be temporarily stored for the shortest possible time and then sent to specific industrial landfills. According to Conama and ABNT standards, asbestos is classified as hazardous waste (Class D) and must be sent to industrial landfills authorized and registered by the Ministry of Economy, in compliance with NR 15.
